**LPC# 031 030 5034 - Cook County  
Mr. Snappy Cleaners/Broadview  
SF/HRS**

# **Preliminary Assessment**

**Title:** CERCLA Preliminary Assessment for Mr. Snappy Cleaners

Mr. Snappy Cleaners

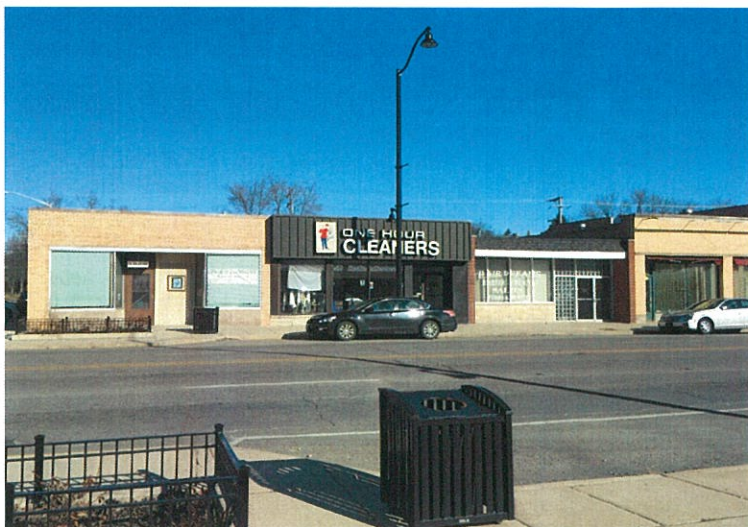
Photo of the front of Mr. Snappy Cleaners.
